Blackmaxx, Tracer, Rampage Retrofit Guide

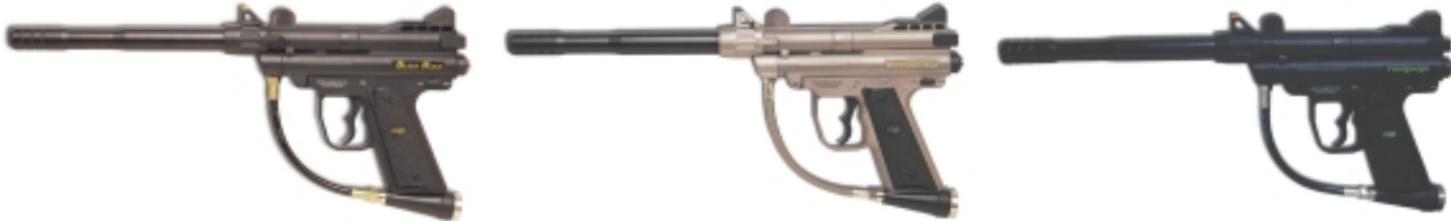
FIGURE 1

All of the markers in figure 1 do not have the external retrofit device installed. However you must check to see if they have the new factory installed safety release device as shown in figure #3 & 4 before playing with this marker! If your marker does not have the factory installed safety release device or the external retrofit device you must call or e-mail PMI to arrange for your free retrofit service. Call PMI toll free at 800-579-1633 or e-mail at info@pminetwork.com for further details regarding returning your marker for this free upgrade. Do not use the marker prior to calling PMI.

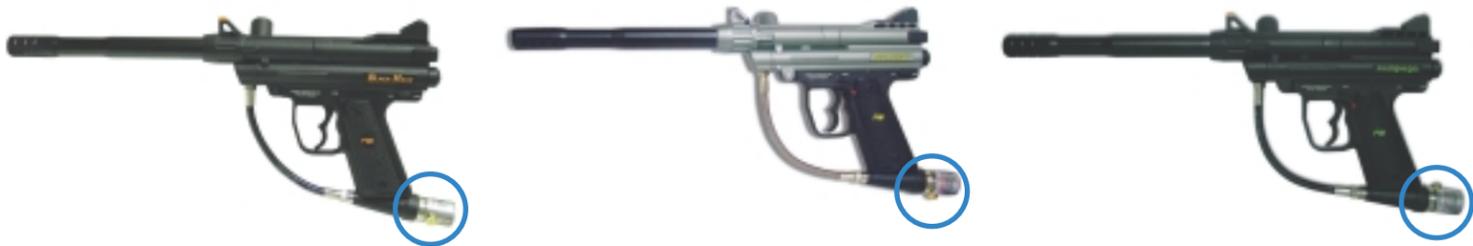
FIGURE 2

All of the markers in figure 2 have the external retrofit device installed as shown circled in blue below. These markers are ready to use.

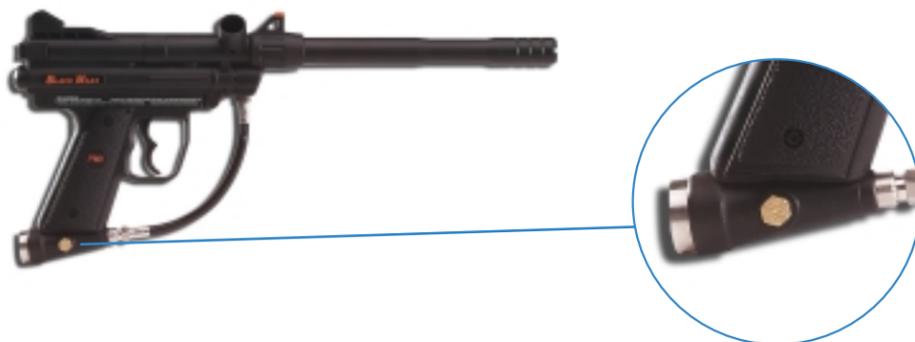
FIGURE 3

The markers shown in figures 3 & 4 have the new factory installed safety release device. These markers are ready to use.
