Leaking from the Feedneck

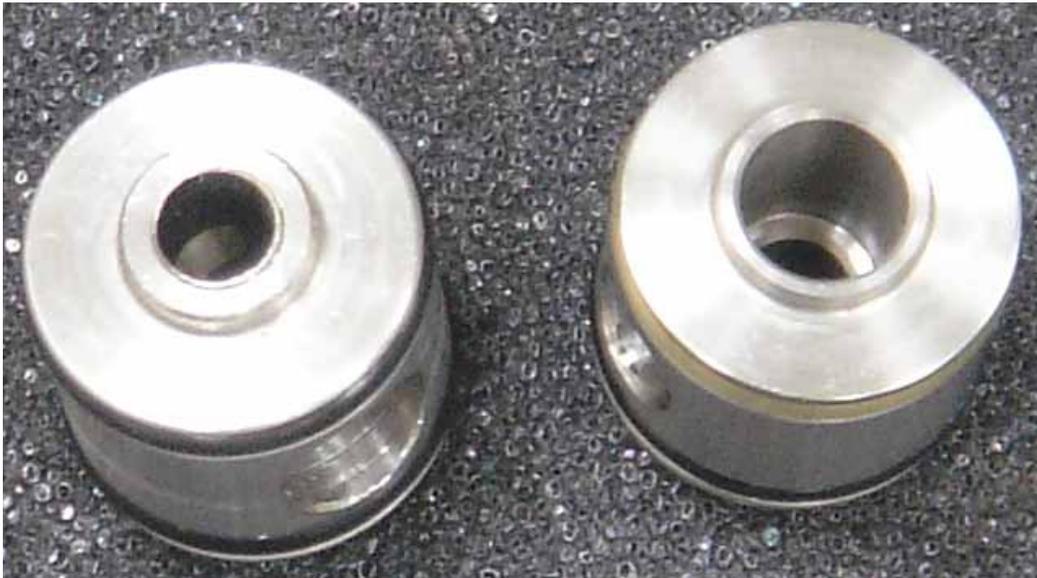
POSSIBLE CAUSE: Valve installed incorrectly

SOLUTION: Bigger opening hole is facing the barrel side

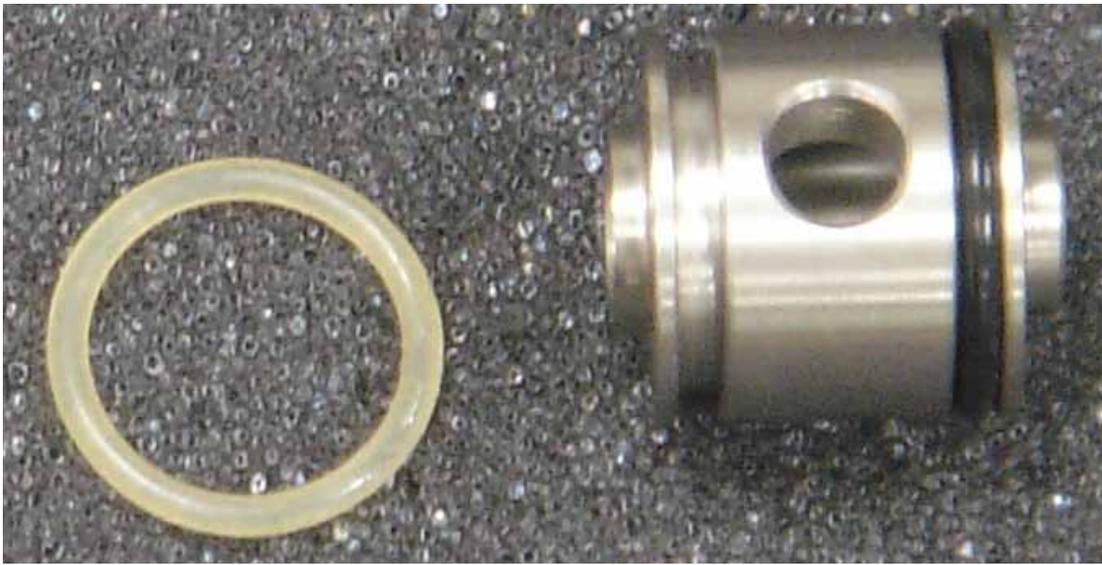
POSSIBLE CAUSE: Front Valve O-Ring (R012) is damaged

SOLUTION: Replace Front Valve O-Ring

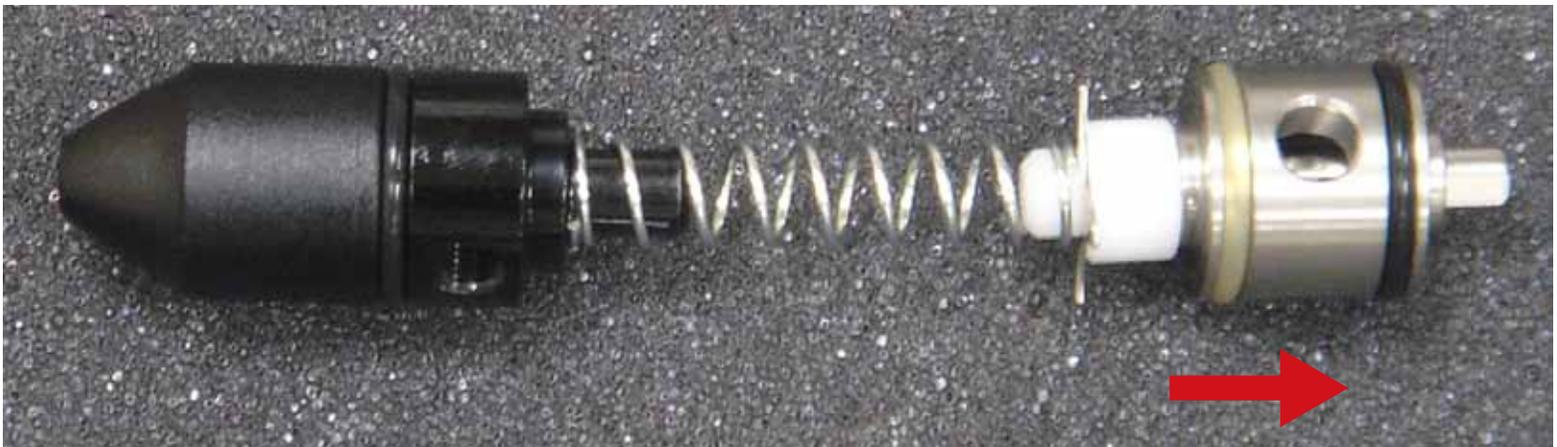
POSSIBLE CAUSE: Cup Seal Guide is jammed in the valve

SOLUTION: Replace cup seal guide and make sure it goes through the valve completely.
