Leaking from the Feedneck

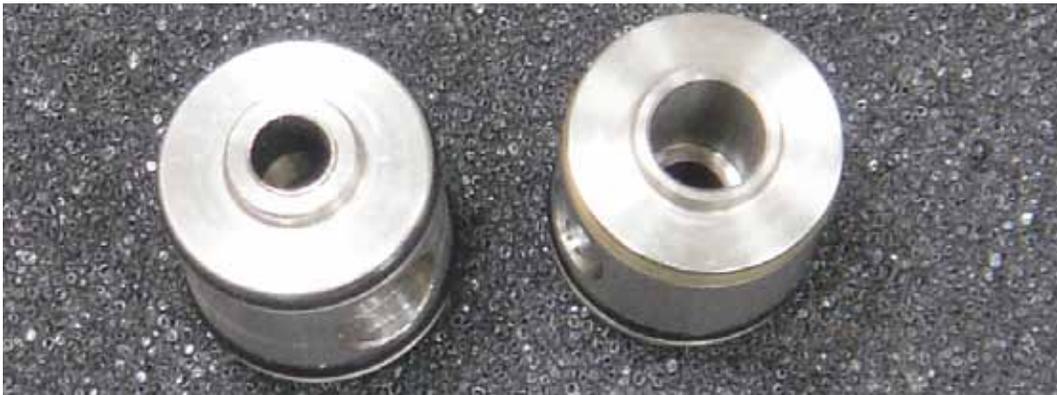
POSSIBLE CAUSE: Valve installed incorrectly.

SOLUTION: Bigger opening hole is facing the barrel side.

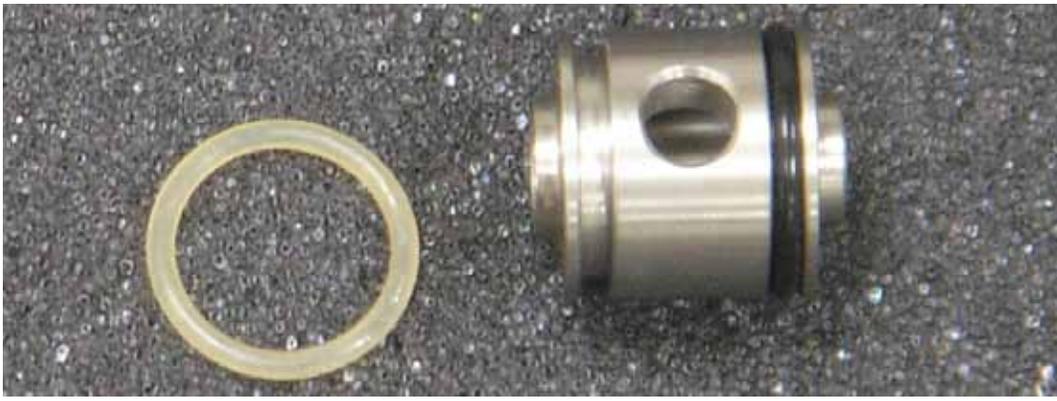
POSSIBLE CAUSE: Front Valve O-Ring (R012) is damaged.

SOLUTION: Replace Front Valve O-Ring.

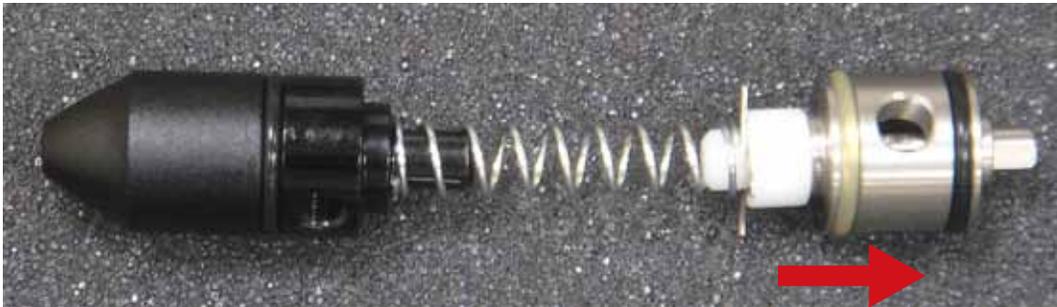
POSSIBLE CAUSE: Cup Seal Guide is jammed in the valve.

SOLUTION: Replace cup seal guide and make sure it goes through the valve completely.
