CO2 FILL STATION REBUILD PROCEDURE

The original MK1 version of the M10 CO2 Fill Station was replaced by the MK2 version in July of 2000. The two versions differ in the type of bottom plug closure used. The MK2 version is easily identified, as it uses "screw-in" type bottom plugs, while the bottom plugs in the MK1 are retained by cross bolts. This rebuild kit services both versions.

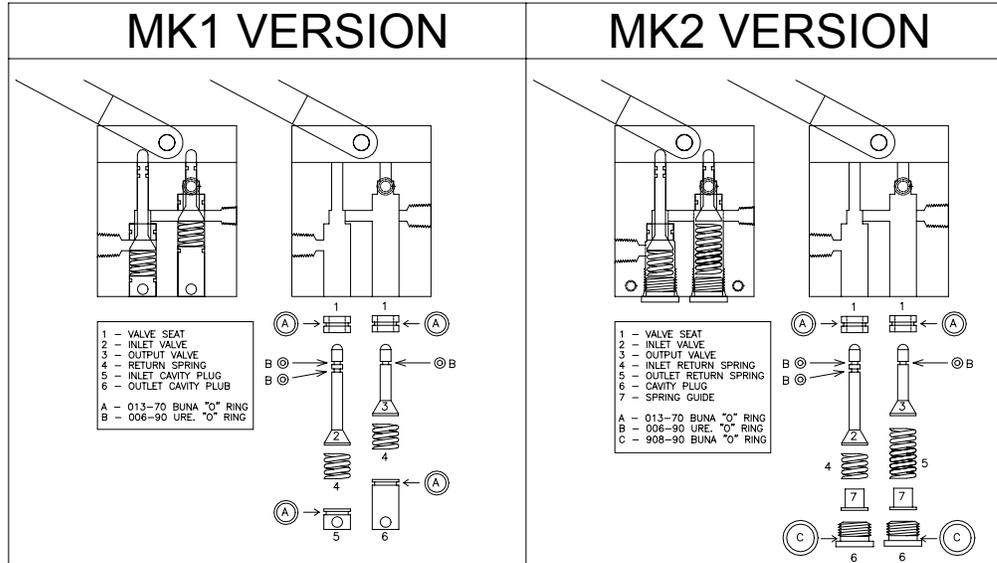
On the MK1 version note that the valves and bottom plugs are different lengths, and must go back into the correct cavity.

On the MK2 version, note that while the valves are still two different lengths, the bottom plugs are now the same length, and two different springs are used. Make sure the correct valve and spring go into the correct cavity. Also note that there is a spring guide that must be placed under each spring.

Once these have been removed, you will be able to remove return springs, and valves. If the valves do not drop out, you can gently push them out from the top. Care should be taken not to scratch or damage the bore that guides the valve stems. You can now change the "O" rings on the valves and bottom plugs.
