Leaking from the 90 Degree Elbow

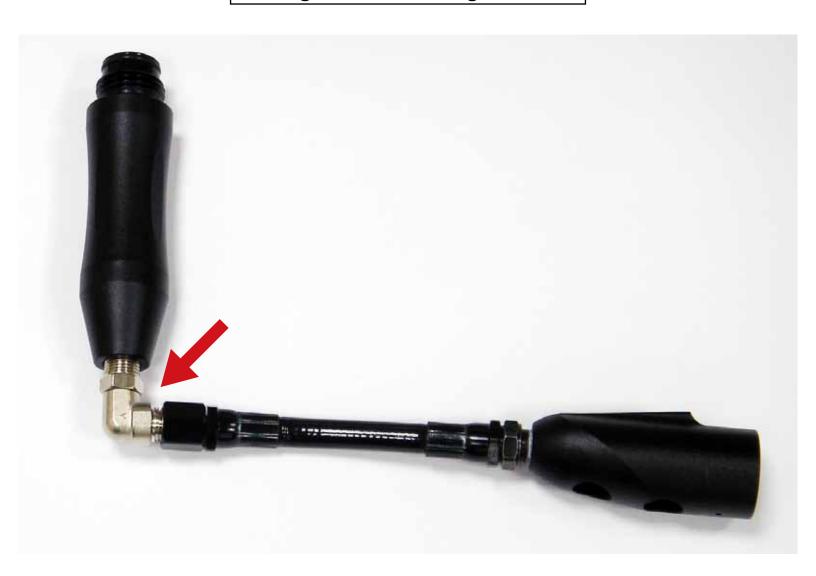
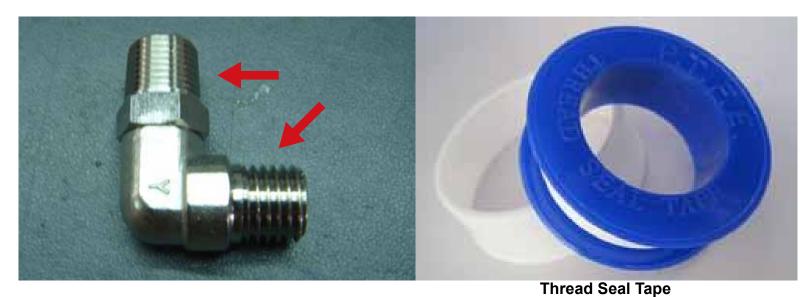
POSSIBLE CAUSE: Braided Hose (P071) is loose from the 90 Degree Elbow.

SOLUTION: Apply Thread Seal Tape and reconnect Braided Hose to Bottom ASA.
