Leaking from the Straight Macroline Elbow

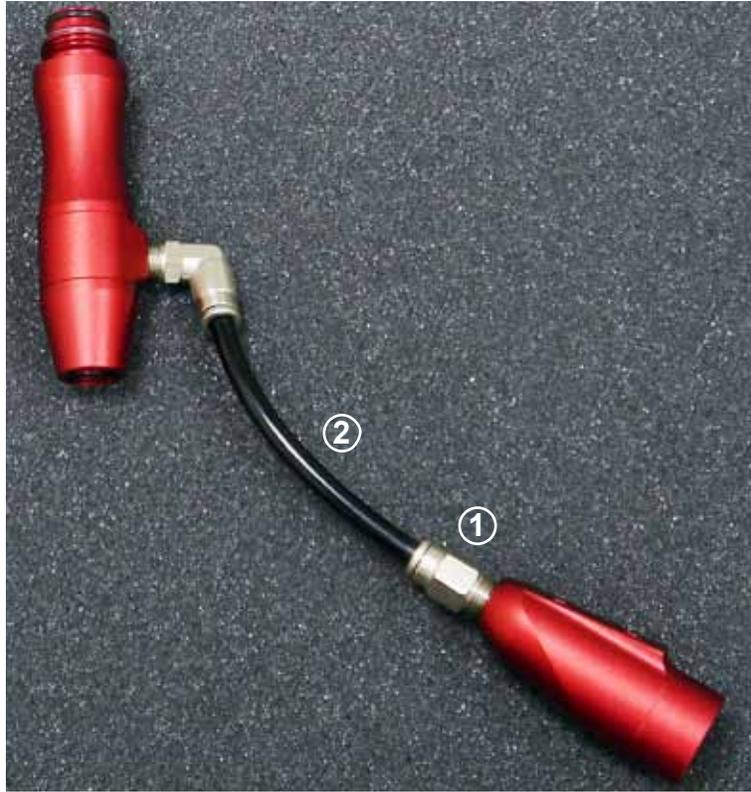
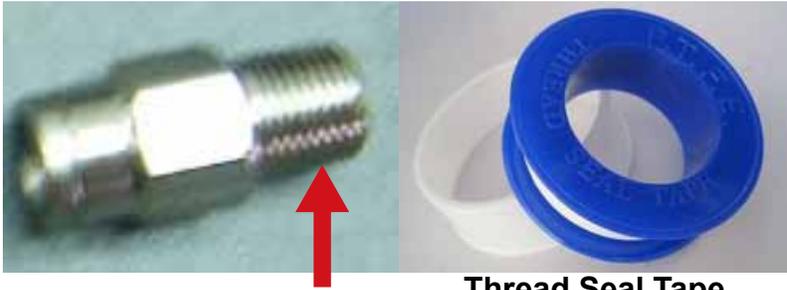
Thread Seal Tape

POSSIBLE CAUSE: Straight Macroline Elbow is damaged.

SOLUTION: Replace Straight Macroline Elbow.

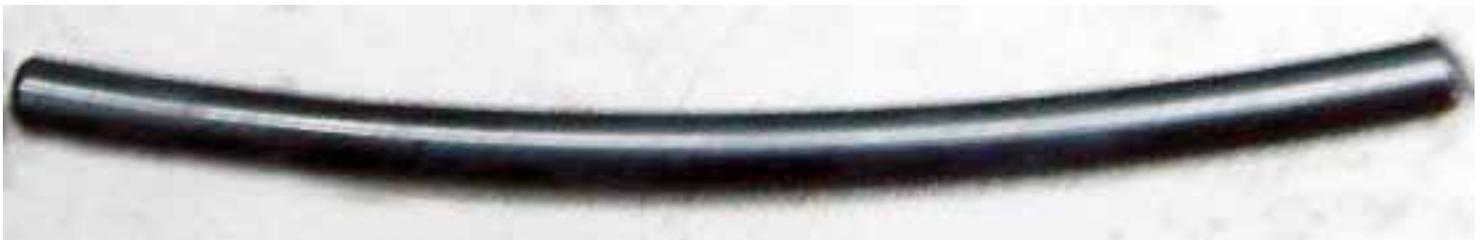
POSSIBLE CAUSE: Macroline Hose is damaged.

SOLUTION: Replace Macroline Hose.
