# Leaking from ASA

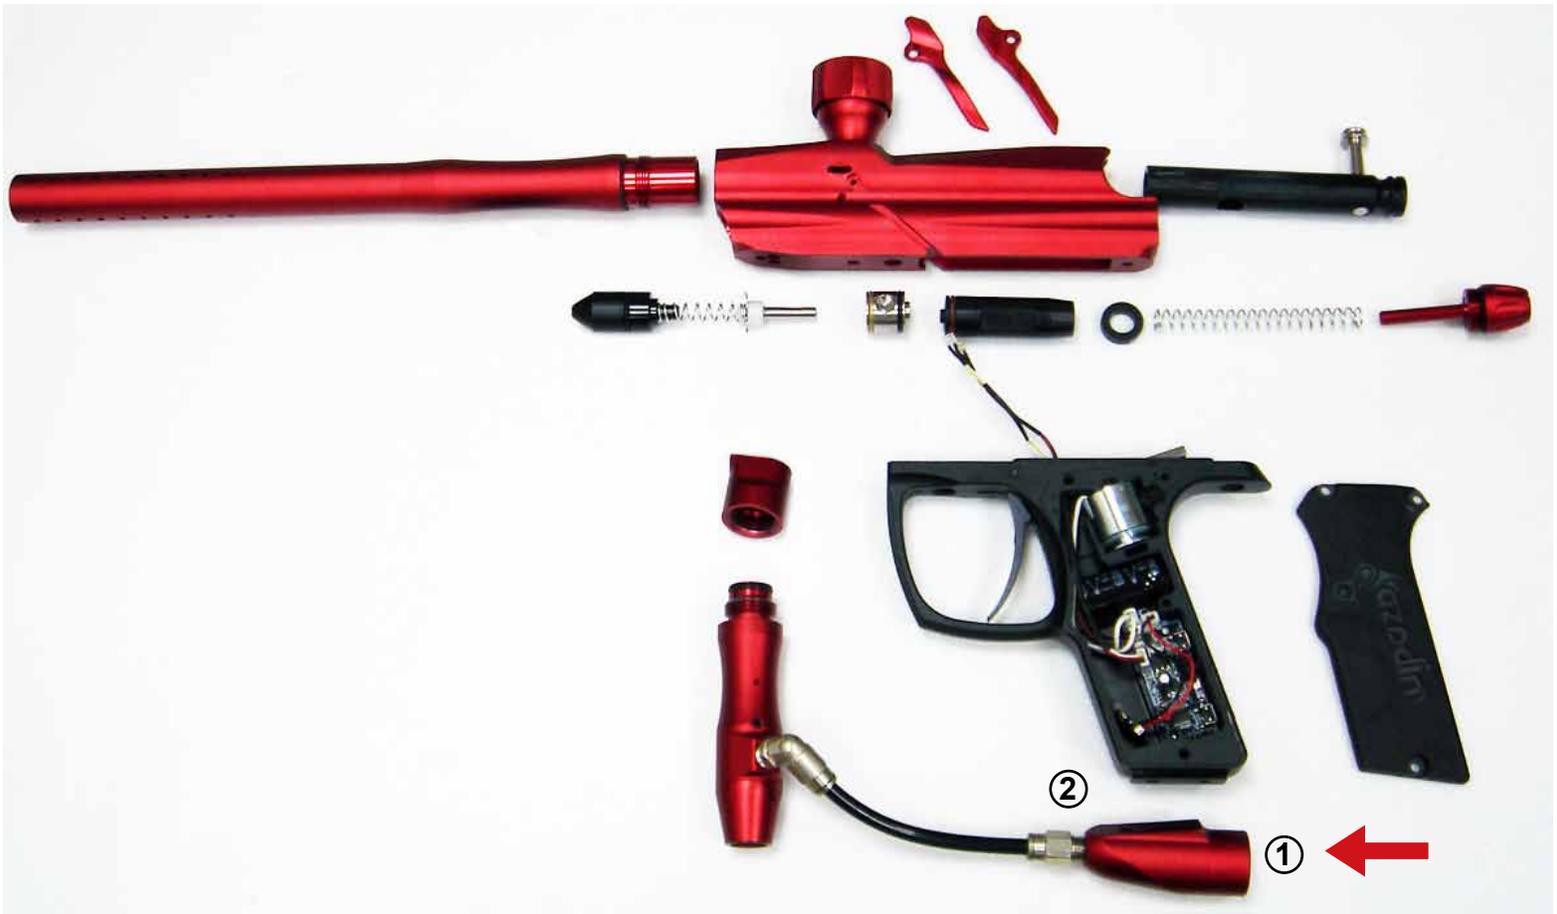
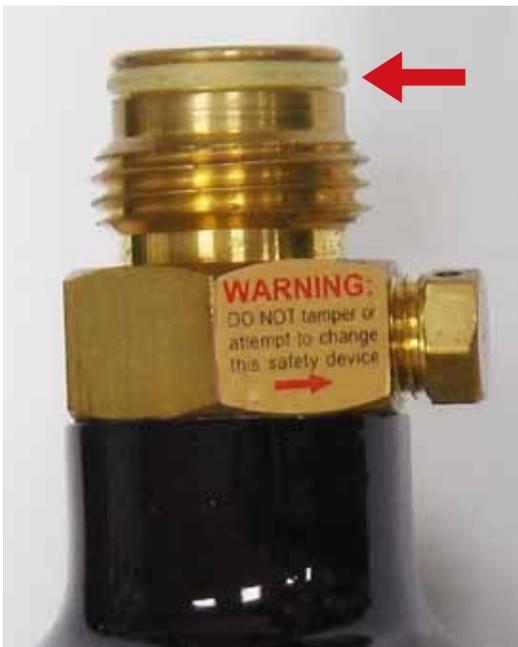
**POSSIBLE CAUSE:** O-Ring on the air tank is damaged.

**SOLUTION:** Replace the O-Ring on the Air Tank.

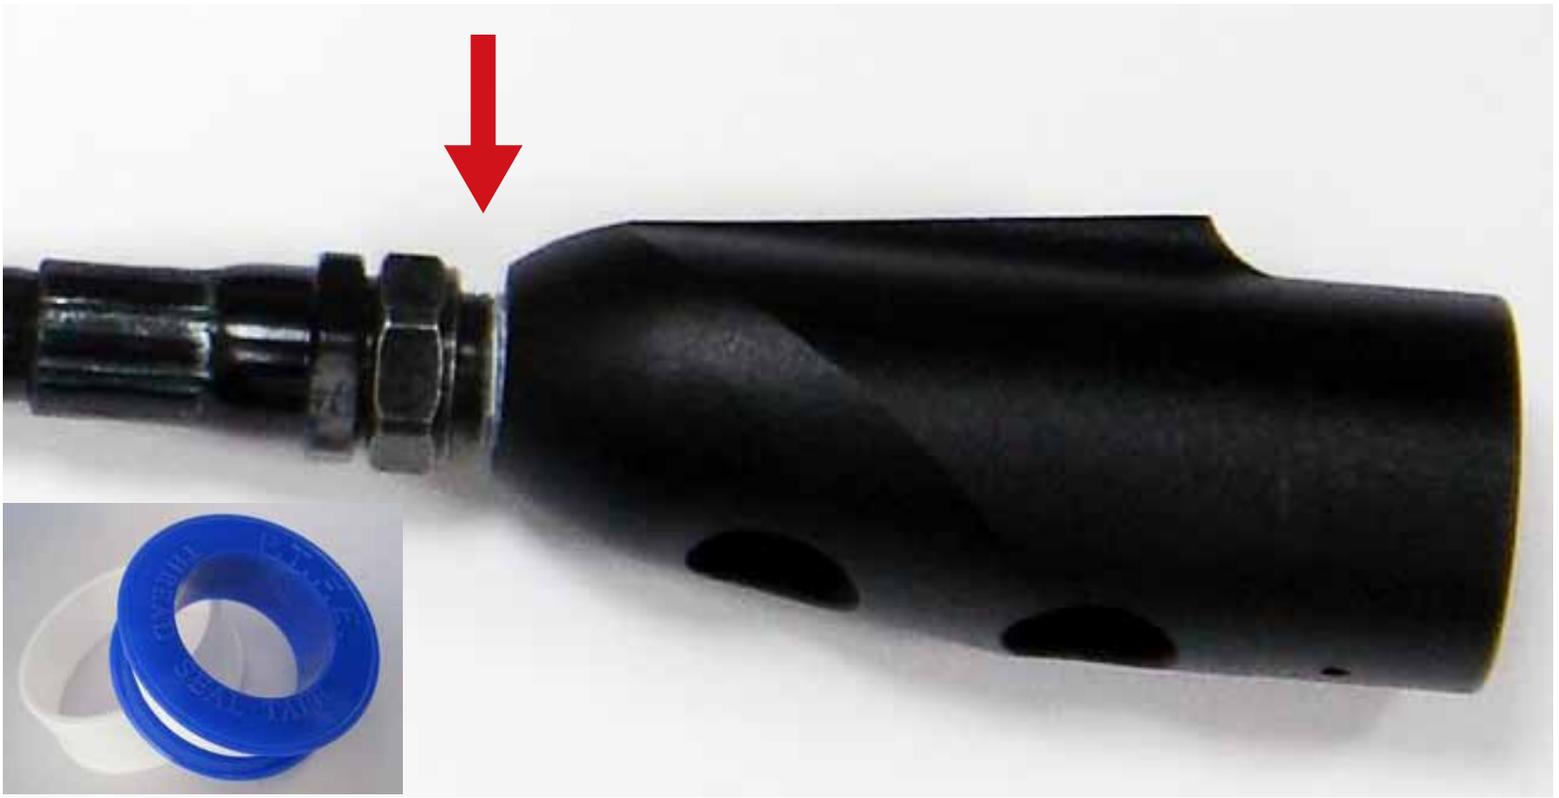
Thread Seal Tape

**POSSIBLE CAUSE:** Braided Hose ( P071) is loose from Bottom ASA ( A021)

**SOLUTION:** Apply Loctite and reconnect Braided Hose to Bottom ASA.  
Leave 24 hrs for successful drying
