Leaking from the 90 Macroline Elbow

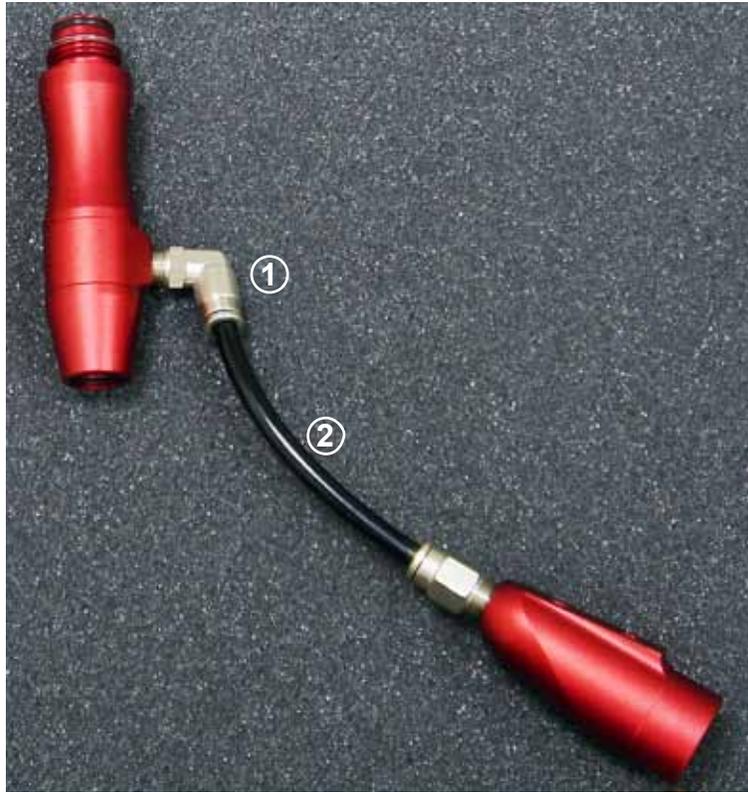
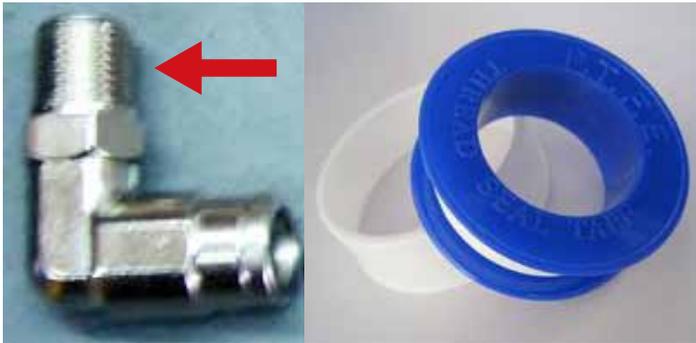
Thread Seal Tape

POSSIBLE CAUSE: 90 Degree Macroline Elbow is damaged.

SOLUTION: Replace 90 Degree Macroline Elbow.

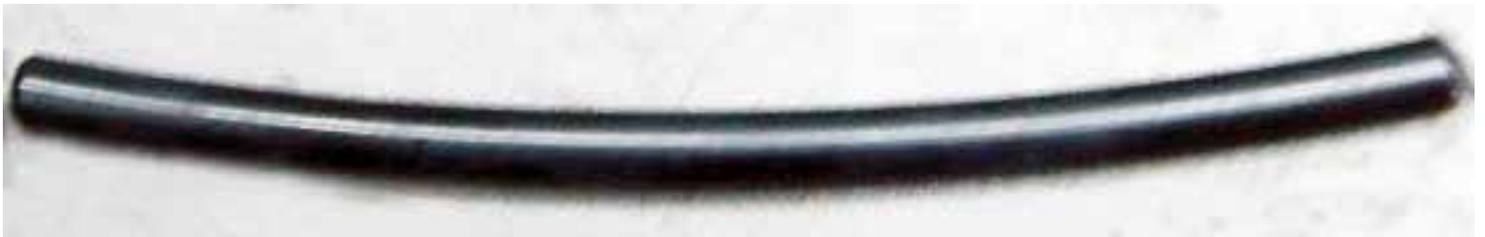
POSSIBLE CAUSE: Macroline Hose is damaged.

SOLUTION: Replace Macroline Hose.
